DAN HOLE POND DAM

NH 00376

PHASE I INSPECTION REPORT  
NATIONAL DAM INSPECTION PROGRAM

NOVEMBER 1978

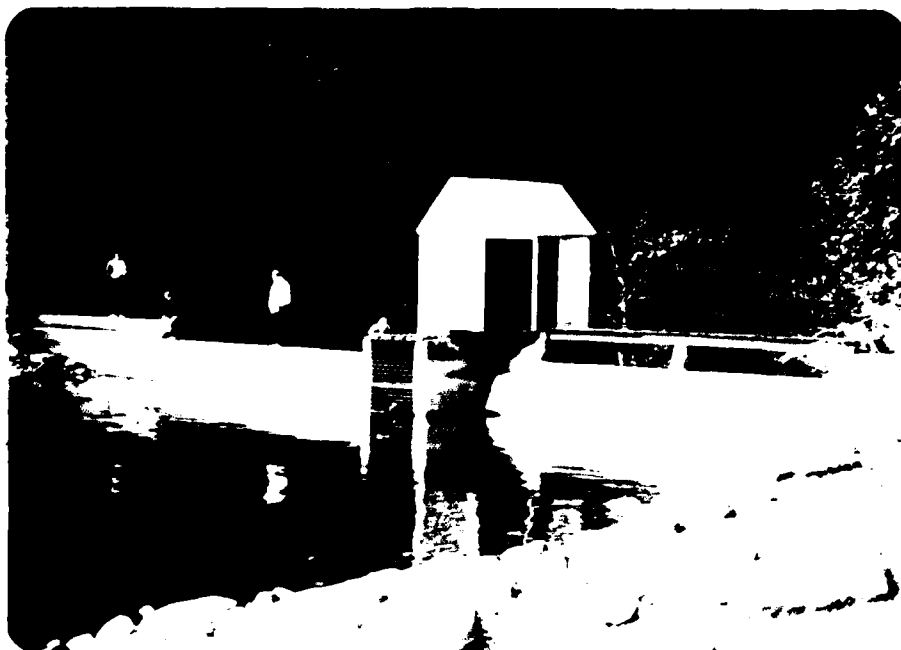
Overview from right side upstream

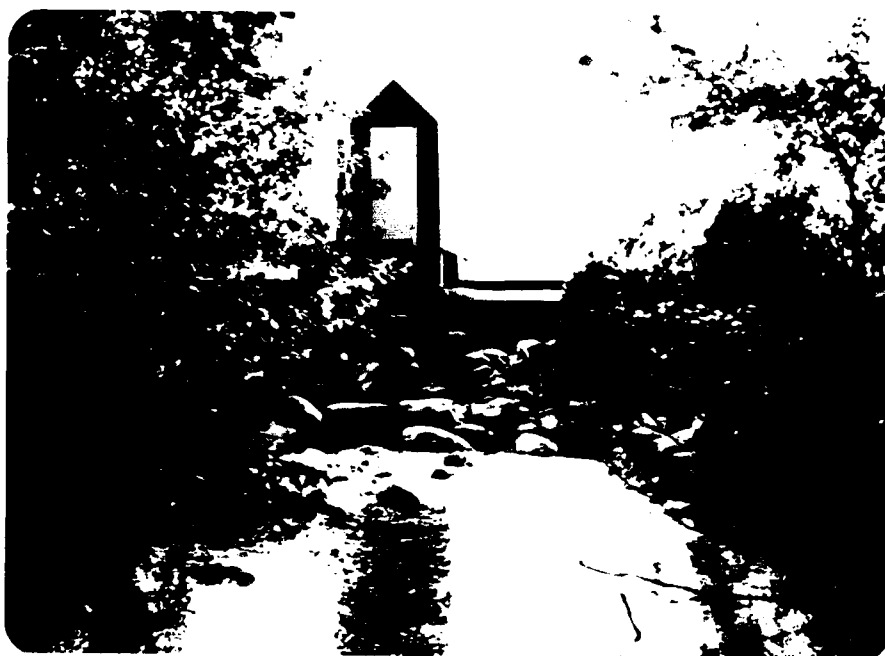
Overview from left side downstream

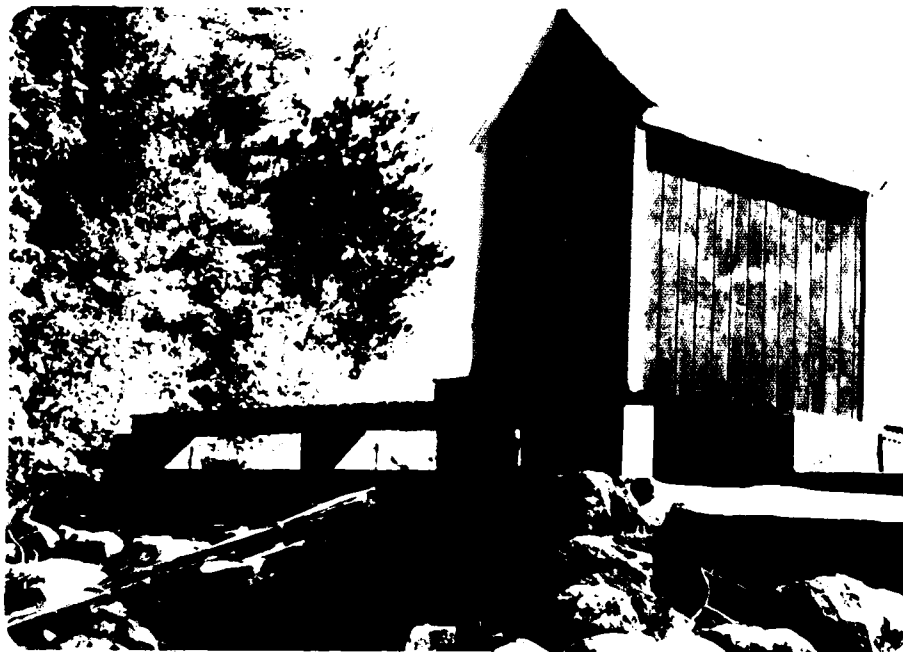
Overview of right side of dam and  
gatehouse from downstream
